NATIONAL TRANSPORTATION SAFETY BOARD

AIRCRAFT ACCIDENT REPORT

CONTINENTAL AIRLINES /
AIR MICRONESIA, INC.
BOEING 727-92C, N18479
YAP AIRPORT
YAP, WESTERN CAROLINE ISLANDS
NOVEMBER 21, 1980

NTSB-AAR-81-7

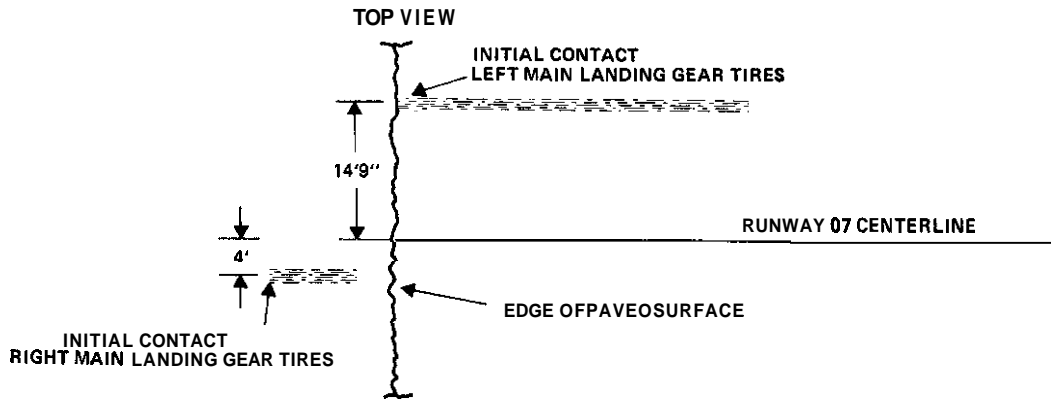
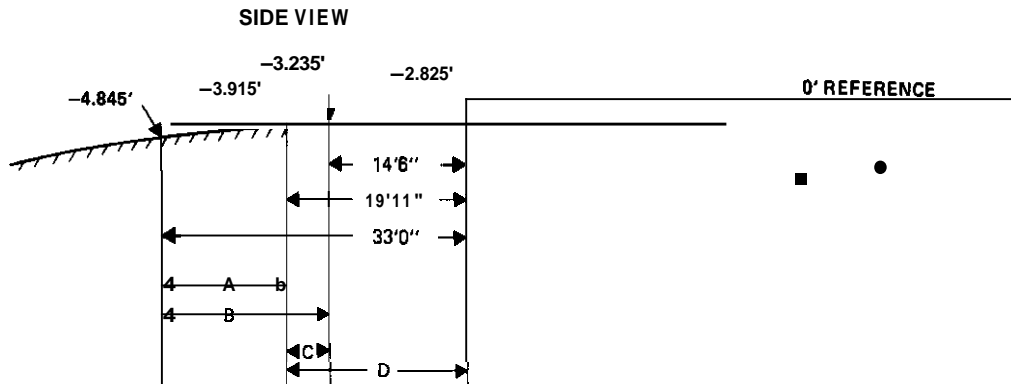
RUNWAY INFORMATION

Yap Airport has one runway oriented 070°/250° magnetic. The runway is 4,820 feet long and about 100 feet wide. The runway base is composed of compacted coral with an asphalt-treated seal covering a width of about 75 feet. The seal coat had deteriorated in many places and there were rutted areas in the touchdown zone. The runway edges were not distinct because of grass which had grown through the surface along the edges. The approach end of runway 7 was not clearly defined, because the surface gradually sloped downward from the runway level. (see appendix D.)

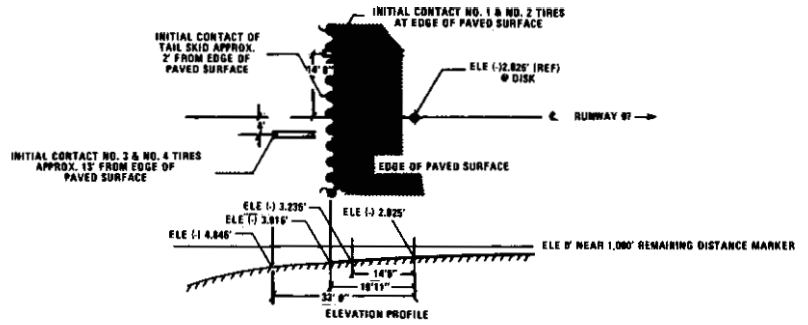
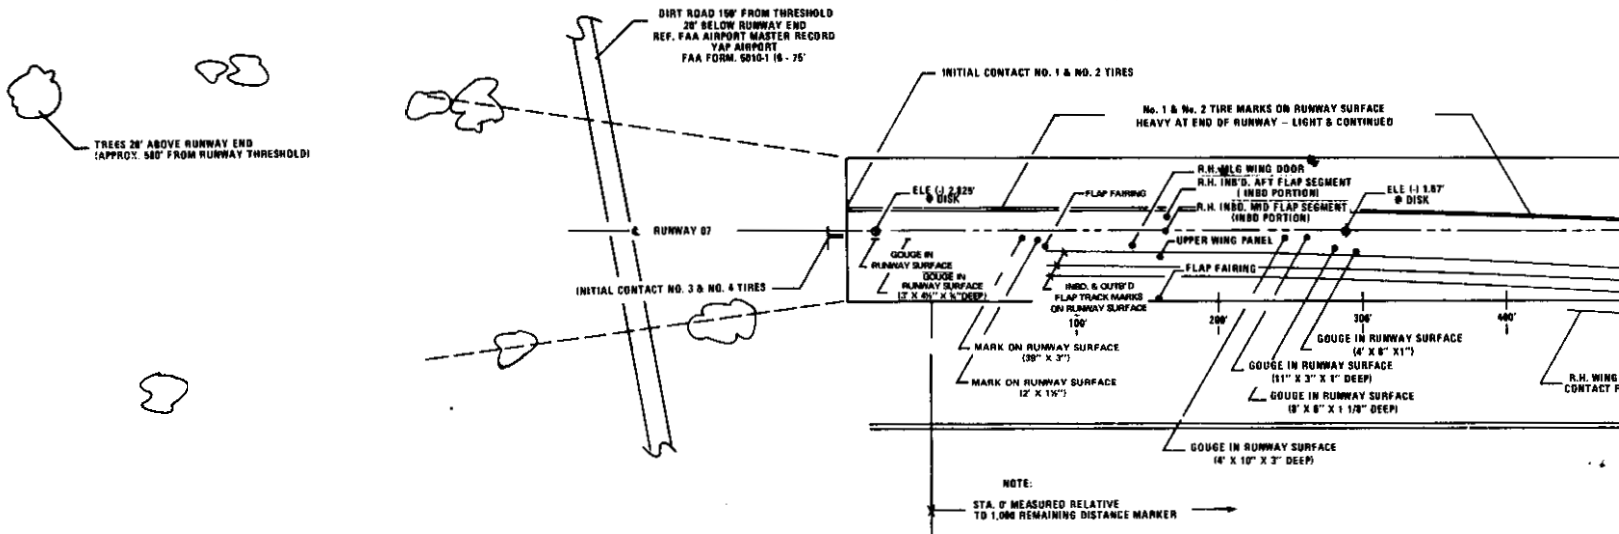
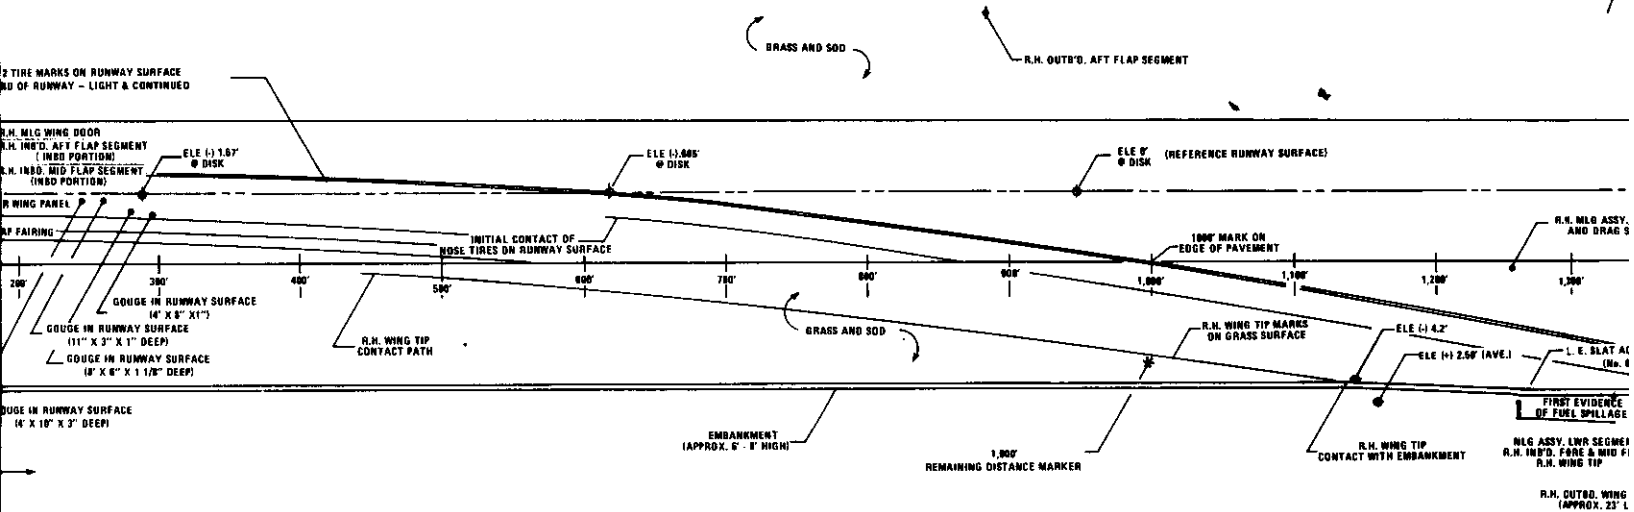
DETAIL @ END OF RUNWAY 07

The first ground impact mark began 13 feet short of the runway threshold. (See appendix G.) This mark was made by the Nos. 3 and 4 tires on the right main landing gear. The left main landing gear tires touched down virtually on the threshold of the runway. A gouge made by the tail skid was found 2 feet short of the runway. Beginning about 100 feet beyond the threshold of the runway were several gouges and marks along the right side of the centerline made by the right wing inboard and outboard flap tracks. Heavy tire marks from the Nos. 1 and 2 tires began about 75 feet beyond the threshold of the runway and continued along the runway, gradually becoming lighter until the aircraft departed the runway surface. About 300 feet beyond the runway threshold, the left main gear tire marks and the scrapemarks from the right wing began a gradual turn to the right. The first evidence of nosewheel tire marks began about 600 feet beyond the threshold of the runway at the same point where the right wingtip began gouging the dirt and grass along the right edge of the runway. The left main tire marks departed the runway surface 1,000 feet from the runway threshold at the same time the right wingtip destroyed a bamboo A-frame touchdown zone marker located adjacent to the runway.

After the aircraft departed the runway surface, the right wingtip began digging into a 6- to 8-foot-high embankment about 1,150 feet from the runway threshold. The aircraft slid up over the embankment where the nose gear and left main gear assemblies broke loose. The right wing outer structure was destroyed by the embankment and fuel was spilled. The aircraft rotated to the right as it slid through dense jungle brush and it came to rest oriented 220° magnetic, about 1,700 feet from initial touchdown.

The right main landing gear assembly came to rest on the runway centerline about 1,260 feet from where the aircraft touched down. The No. 4 tire was found deflated, and a few pieces of rubber from the tread were missing. Two pieces of the tread were located along the left side of the runway about 100 to 200 feet from initial touchdown. The No. 3 tire remained inflated. The left main landing gear tires remained inflated during the accident. They showed evidence of scraping and gouging in an angular direction relative to the tread.
