NATIONAL TRANSPORTATION SAFETY BOARD

AIRCRAFT ACCIDENT REPORT

CONTINENTAL AIRLINES /
AIR MICRONESIA, INC.
BOEING 727-92C, N18479
YAP AIRPORT
YAP, WESTERN CAROLINE ISLANDS
NOVEMBER 21, 1980

NTSB-AAR-81-7

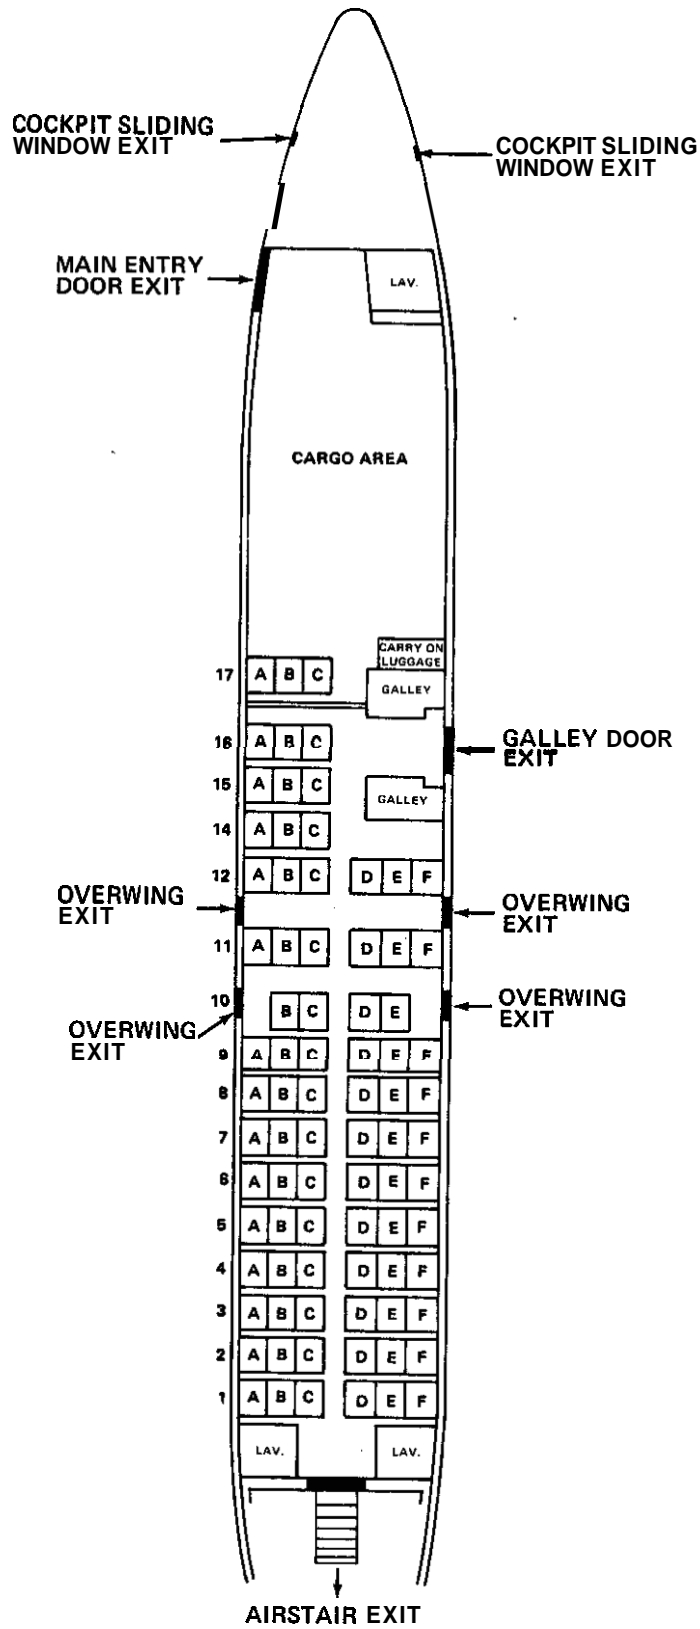
Figure 1.--Aircraft seating and exit locations.

The aircraft was manufactured as a convertible cargo-passenger type. At the time of the accident it was configured for two pallets of cargo forward and 78 passenger seats in the aft cabin. (See figure 1.) As part of the certification for operation in the mixed configuration, the aft airstair door exit was a required emergency exit. A pneumatically actuated emergency "blow-down" system was required to be operational to provide positive opening of that exit with the aircraft in the most adverse exit opening condition that would result from the collapse of one or more of the landing gear. The system was reportedly operational for the flight.

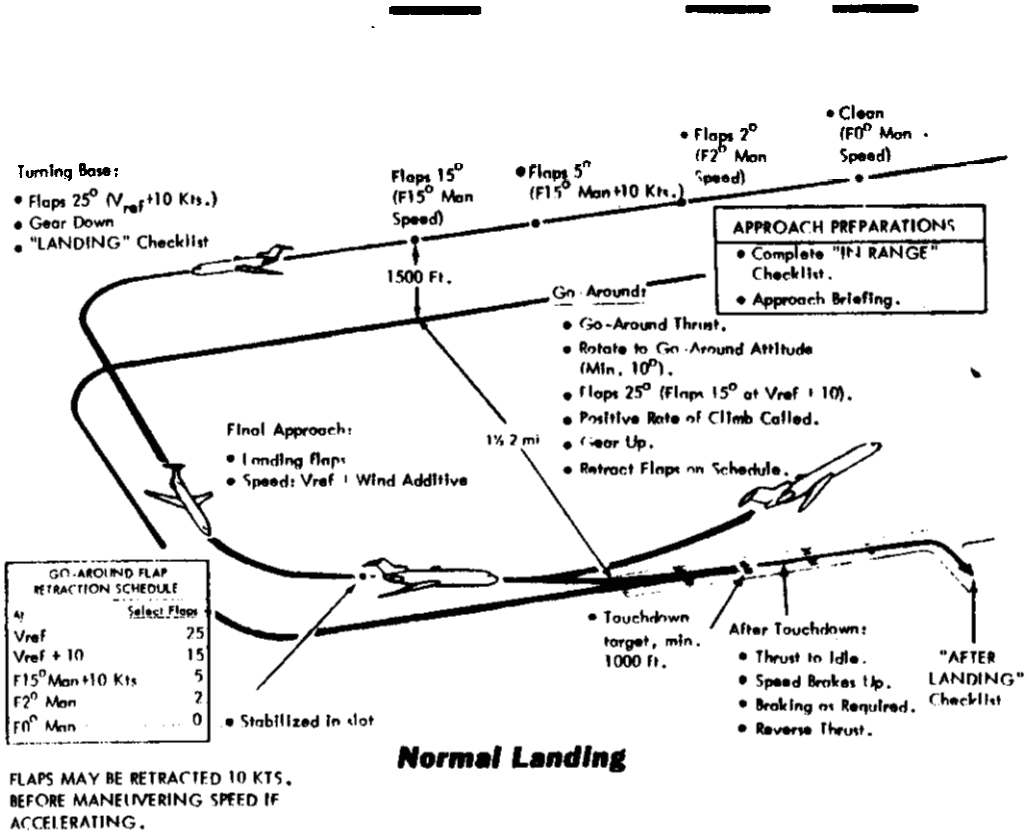
Figure 3.-- Depiction of normal landing from flight manual.

The Continental Airlines flight manual for the Boeing 727-100/100C graphically depicts the normal approach situation. (See figures 3 and 4.) Flap and landing gear extension points were selected to minimize crew workload and thrust changes during the approach. The flight manual states, in part, "The airplane must be stabilized on final approach at least 500 ft above field elevation." Following are excerpts from the flight manual regarding other landing procedures:

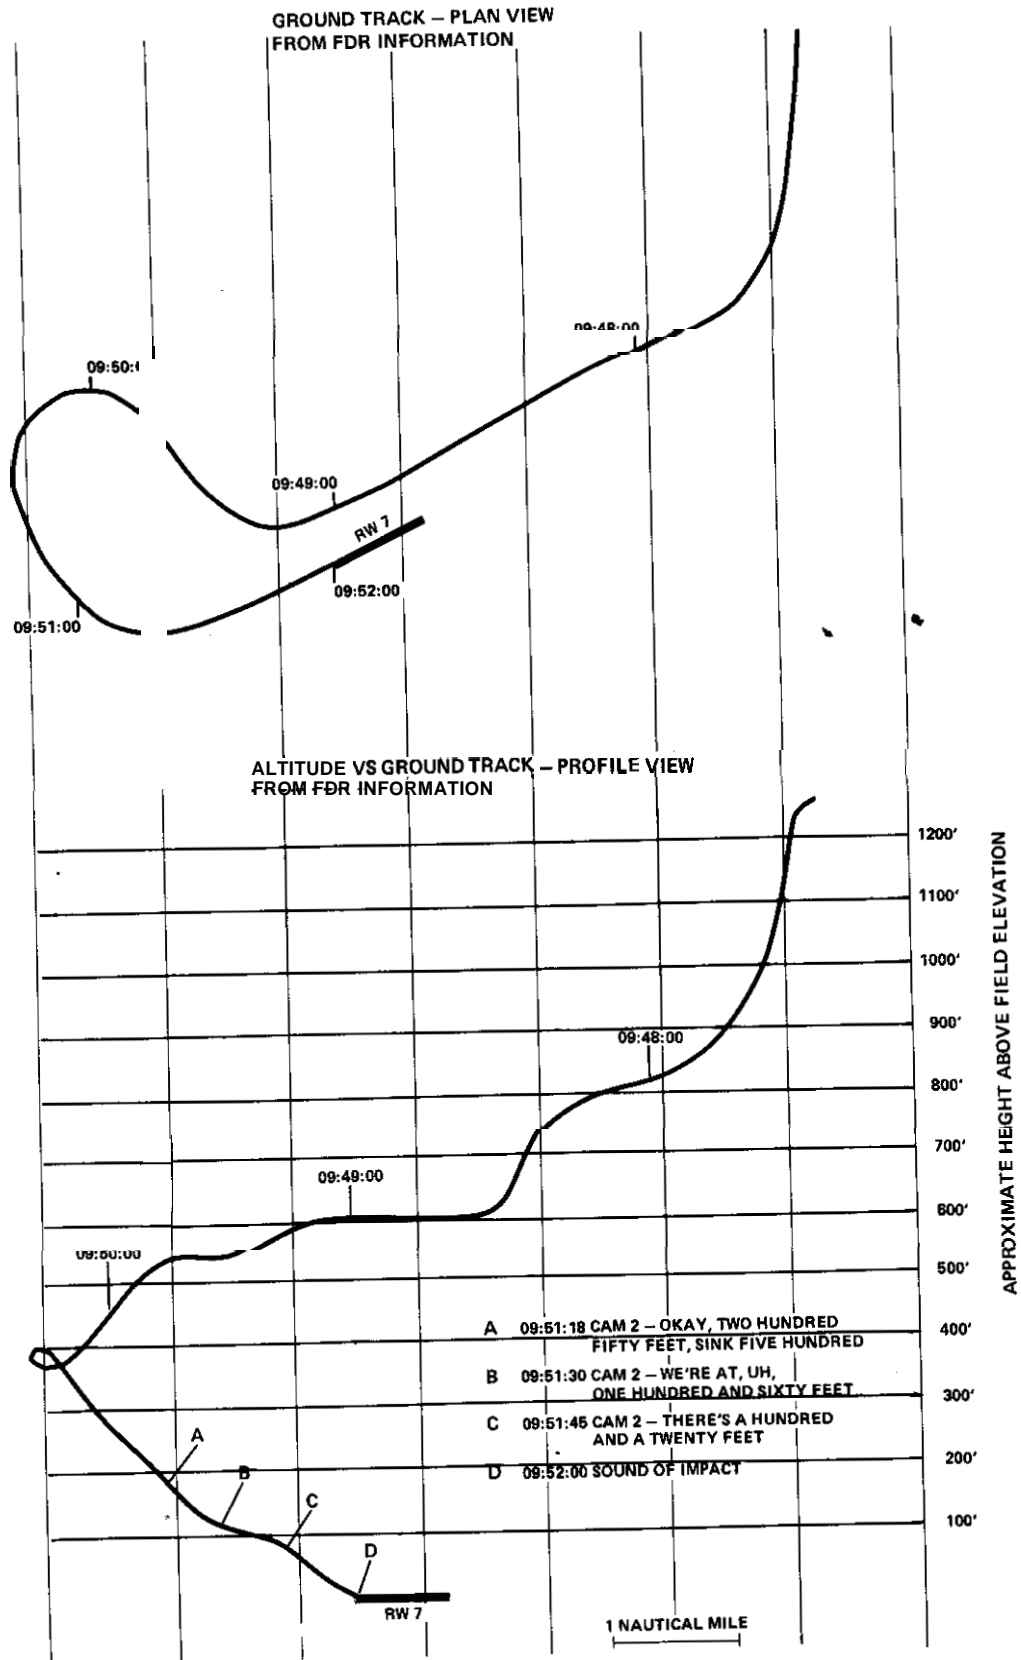
FLIGHT DATA RECORDER TRACES

A Fairchild model 5424 flight data recorder (FDR), serial No. 6061, was installed in N18479. The recorder was recovered from the wreckage and sent to the Safety Board's laboratory in Washington, D.C., for examination. The recorder sustained no impact or fire damage. The metal foil recording medium was examined, and all traces were found to have recorded in a clear and active manner with no evidence of malfunction.
